NPIC/R-157/64
March 1964

PHOTOGRAPHIC INTERPRETATION REPORT

KURUMOCH ROCKET ENGINE TEST FACILITY, USSR

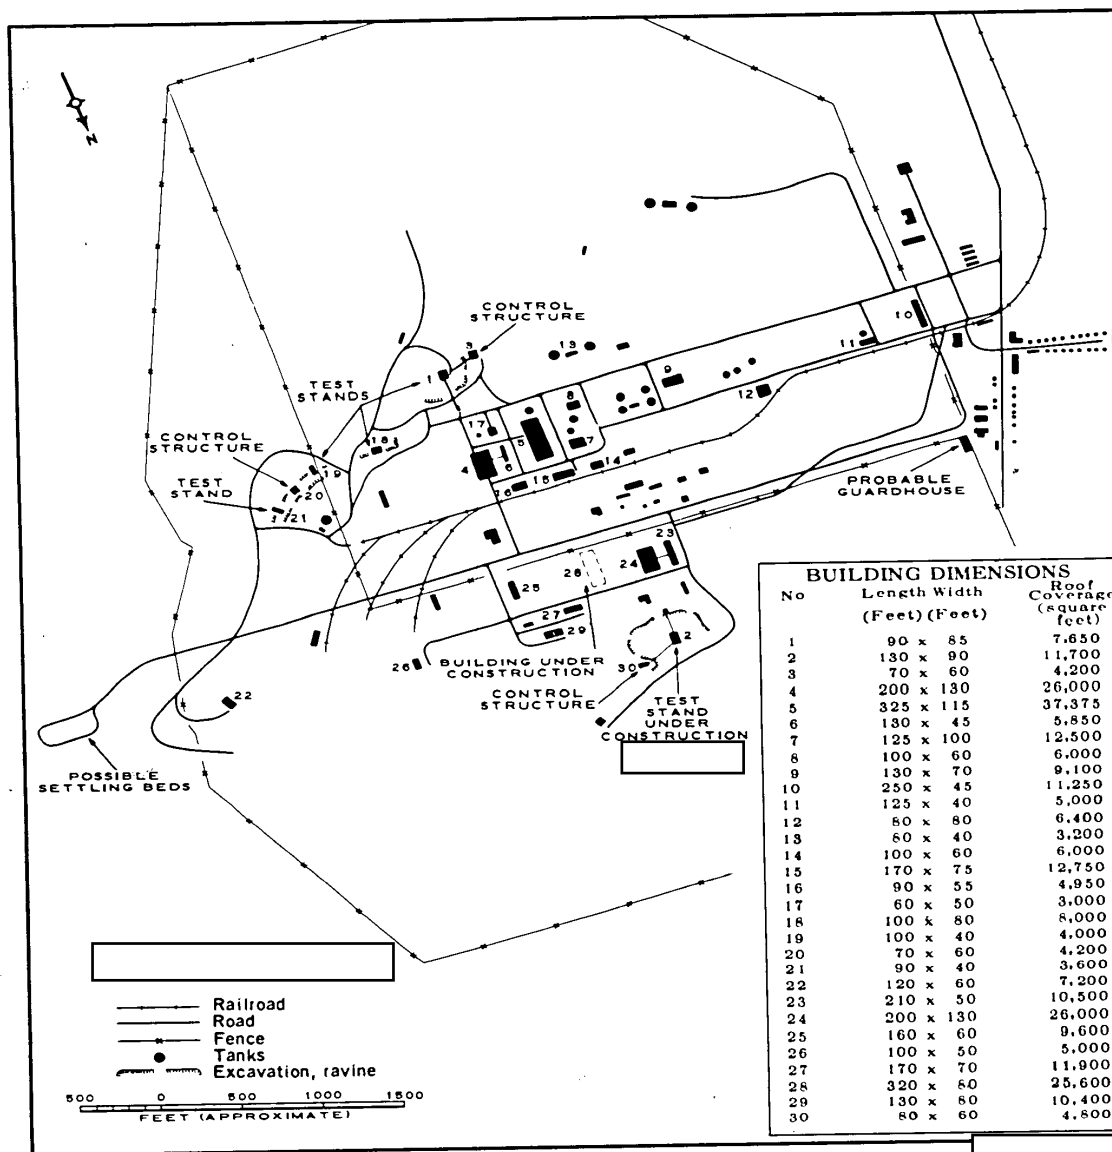
FIGURE 3. KURUMOCH ROCKET ENGINE TEST FACILITY.

1. The installation contains five test stands: a vertical test stand (item 1, Figure 3), a vertical test stand under construction (item 2), and three smaller test stands (items 18, 19, and 21). Adjoining each of the two vertical test stands is a support facility containing a check-out building and other structures.

6. The operational support facilities adjoining the two large test stands are duplicates of each other in part and appear to be duplicates in many other respects. Items 4 and 24, 6 and 23 are matching pairs, and items 5 and 28, 15 and 27 are possible matching pairs. The apparent duplication may indicate either that the support facilities do not contain industrial processes which serve the entire test facility or that the items to be tested at the two large test stands are different.

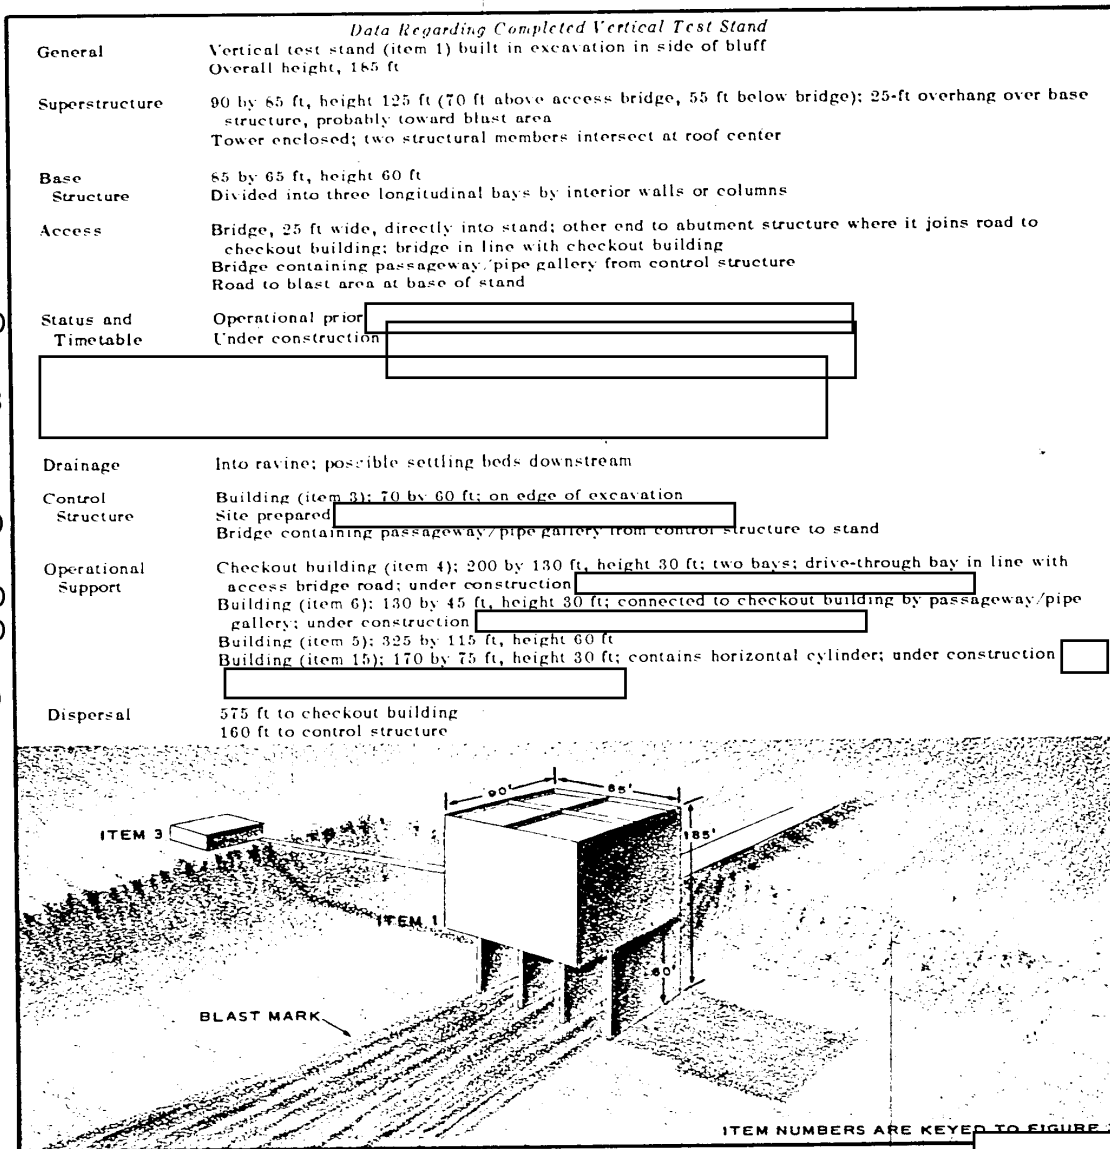
FIGURE 4. COMPLETED VERTICAL TEST STAND (Item 1, Figure 3).

2. The vertical test stand (item 1) is currently operational and contains one test position. The stand has a single symmetrical blast mark, the axis of which is centered on the stand with its width next to the stand being the same as the width of the stand. (For additional data, see Figure 4.)

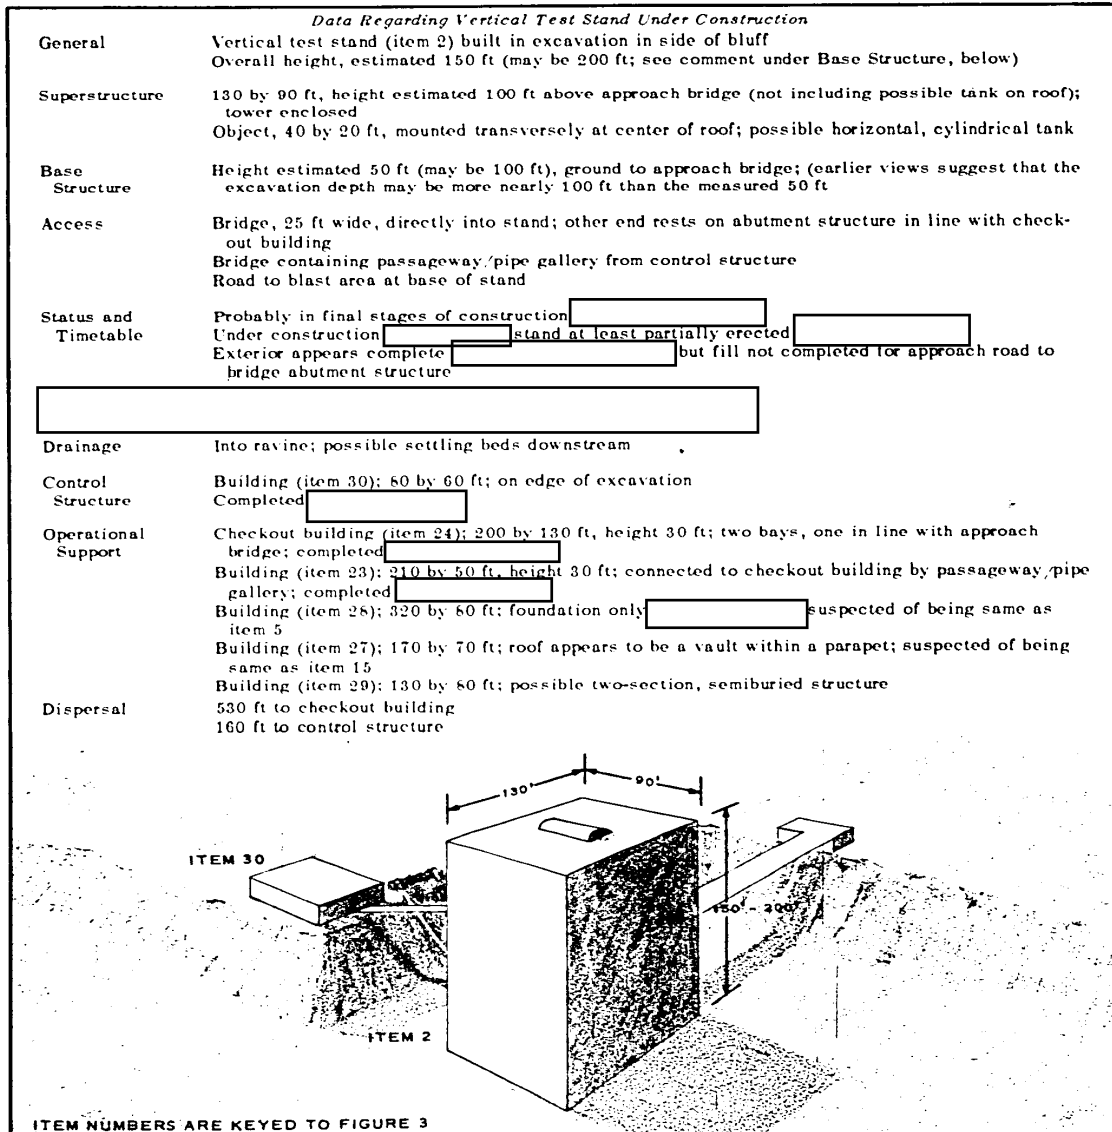
FIGURE 5. VERTICAL TEST STAND UNDER CONSTRUCTION (Item 2, Figure 3).

3. The vertical test stand under construction (item 2) is in the final stages of construction. It is larger than the other vertical test stand and probably contains one test position. The construction status is indicated by the completion of the structure and lack of an access road; that it probably has one position is indicated by the shape of the stand. (For additional data, see Figure 5.)

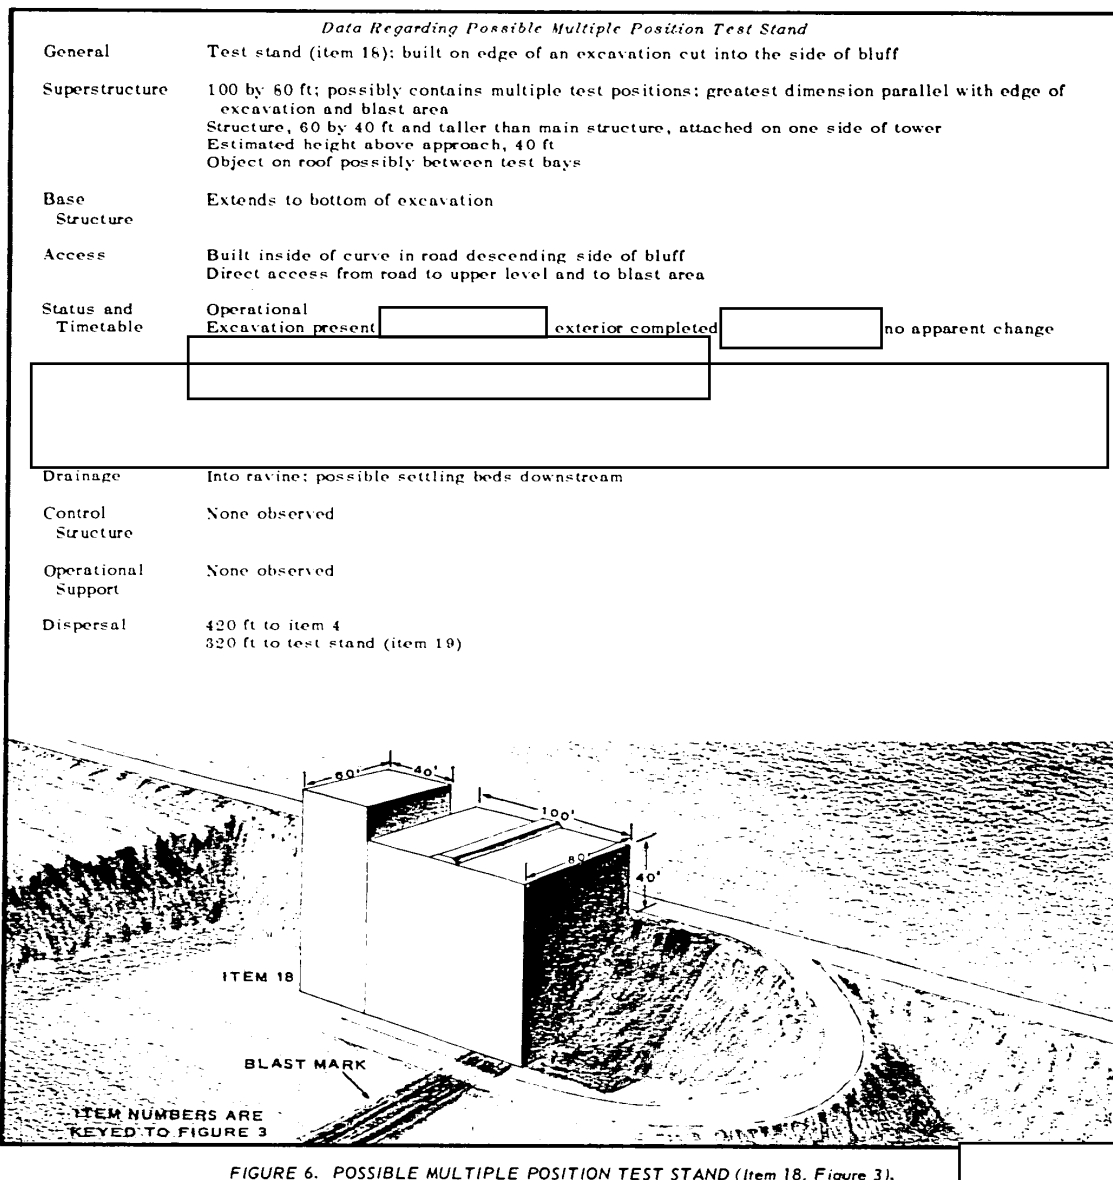
FIGURE 6. POSSIBLE MULTIPLE POSITION TEST STAND (Item 18, Figure 3).

4. One of the smaller stands (item 18) is currently operational and probably contains multiple test positions as indicated by its shape and the size and position of the blast mark. (For additional data, see Figure 6.)

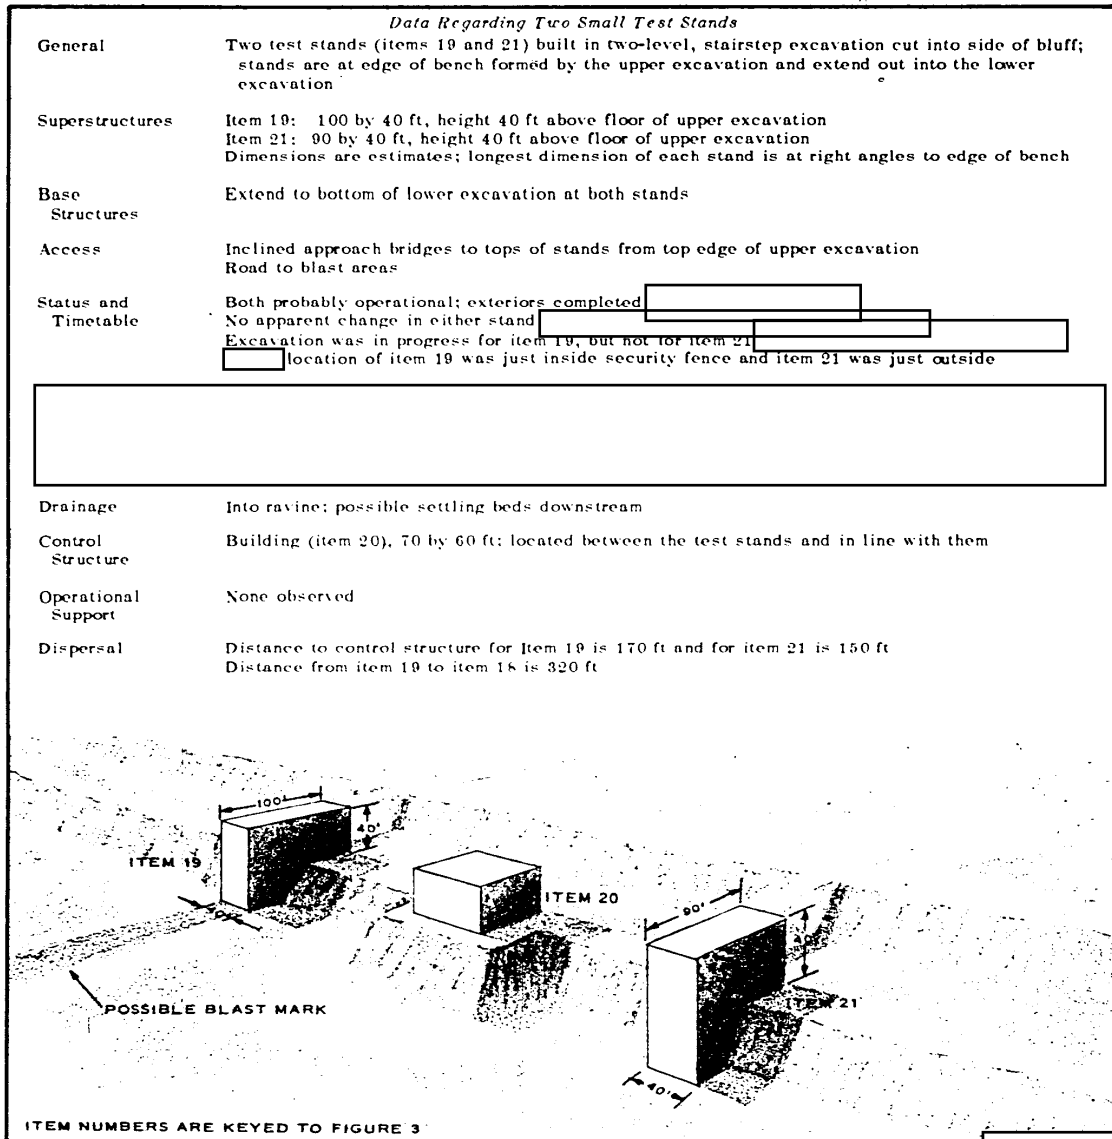
FIGURE 7. TWO SMALL TEST STANDS AND CONTROL STRUCTURE (Items 19, 20, and 21, Figure 3).

5. The other two smaller stands (items 19 and 21) are similar in appearance, are different from the other stands, and are probably operational. The access bridge at each stand leads to the top of the stand. Each stand contains one test position; this is indicated by the presence of one centered possible blast mark at item 19, by the lack of apparent change [redacted] and by the shapes of the stands. (For additional data, see Figure 7.)
